CONDITIONAL USE PERMIT APPLICATION

**Conditional Use Permit Application for Harmoni
Towers' ID0003867_Naples & Verizon Wireless'
Naples Wireless Communications Facility**

Harmoni Towers – ID0003867_Naples
Communication Tower—Conditional Use Permit

Request: Conditional Use Permit review to construct a new wireless communication tower facility and install associated ground equipment used for wireless communication transmissions.

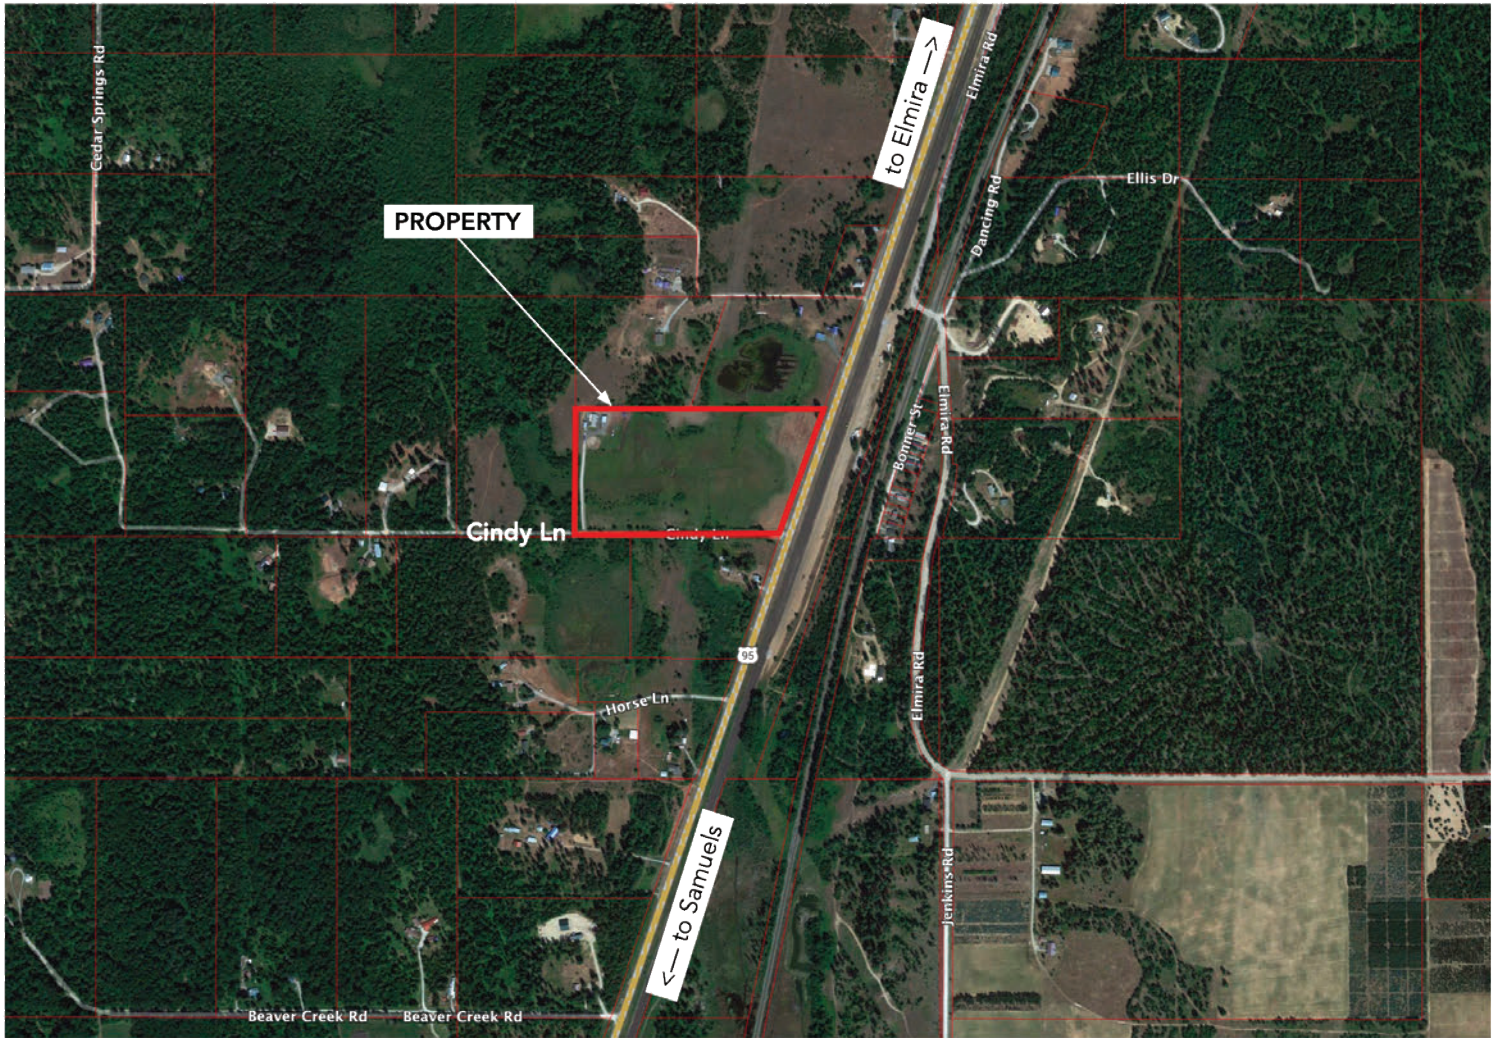
Figure 1
Vicinity Map
Dolyniuk Trust
SPO Naples

211 Cindy Lane, Sandpoint, ID
RP59N01W097510A
T59N, R1W, portion of Sec 9
48.47723, -116.46786

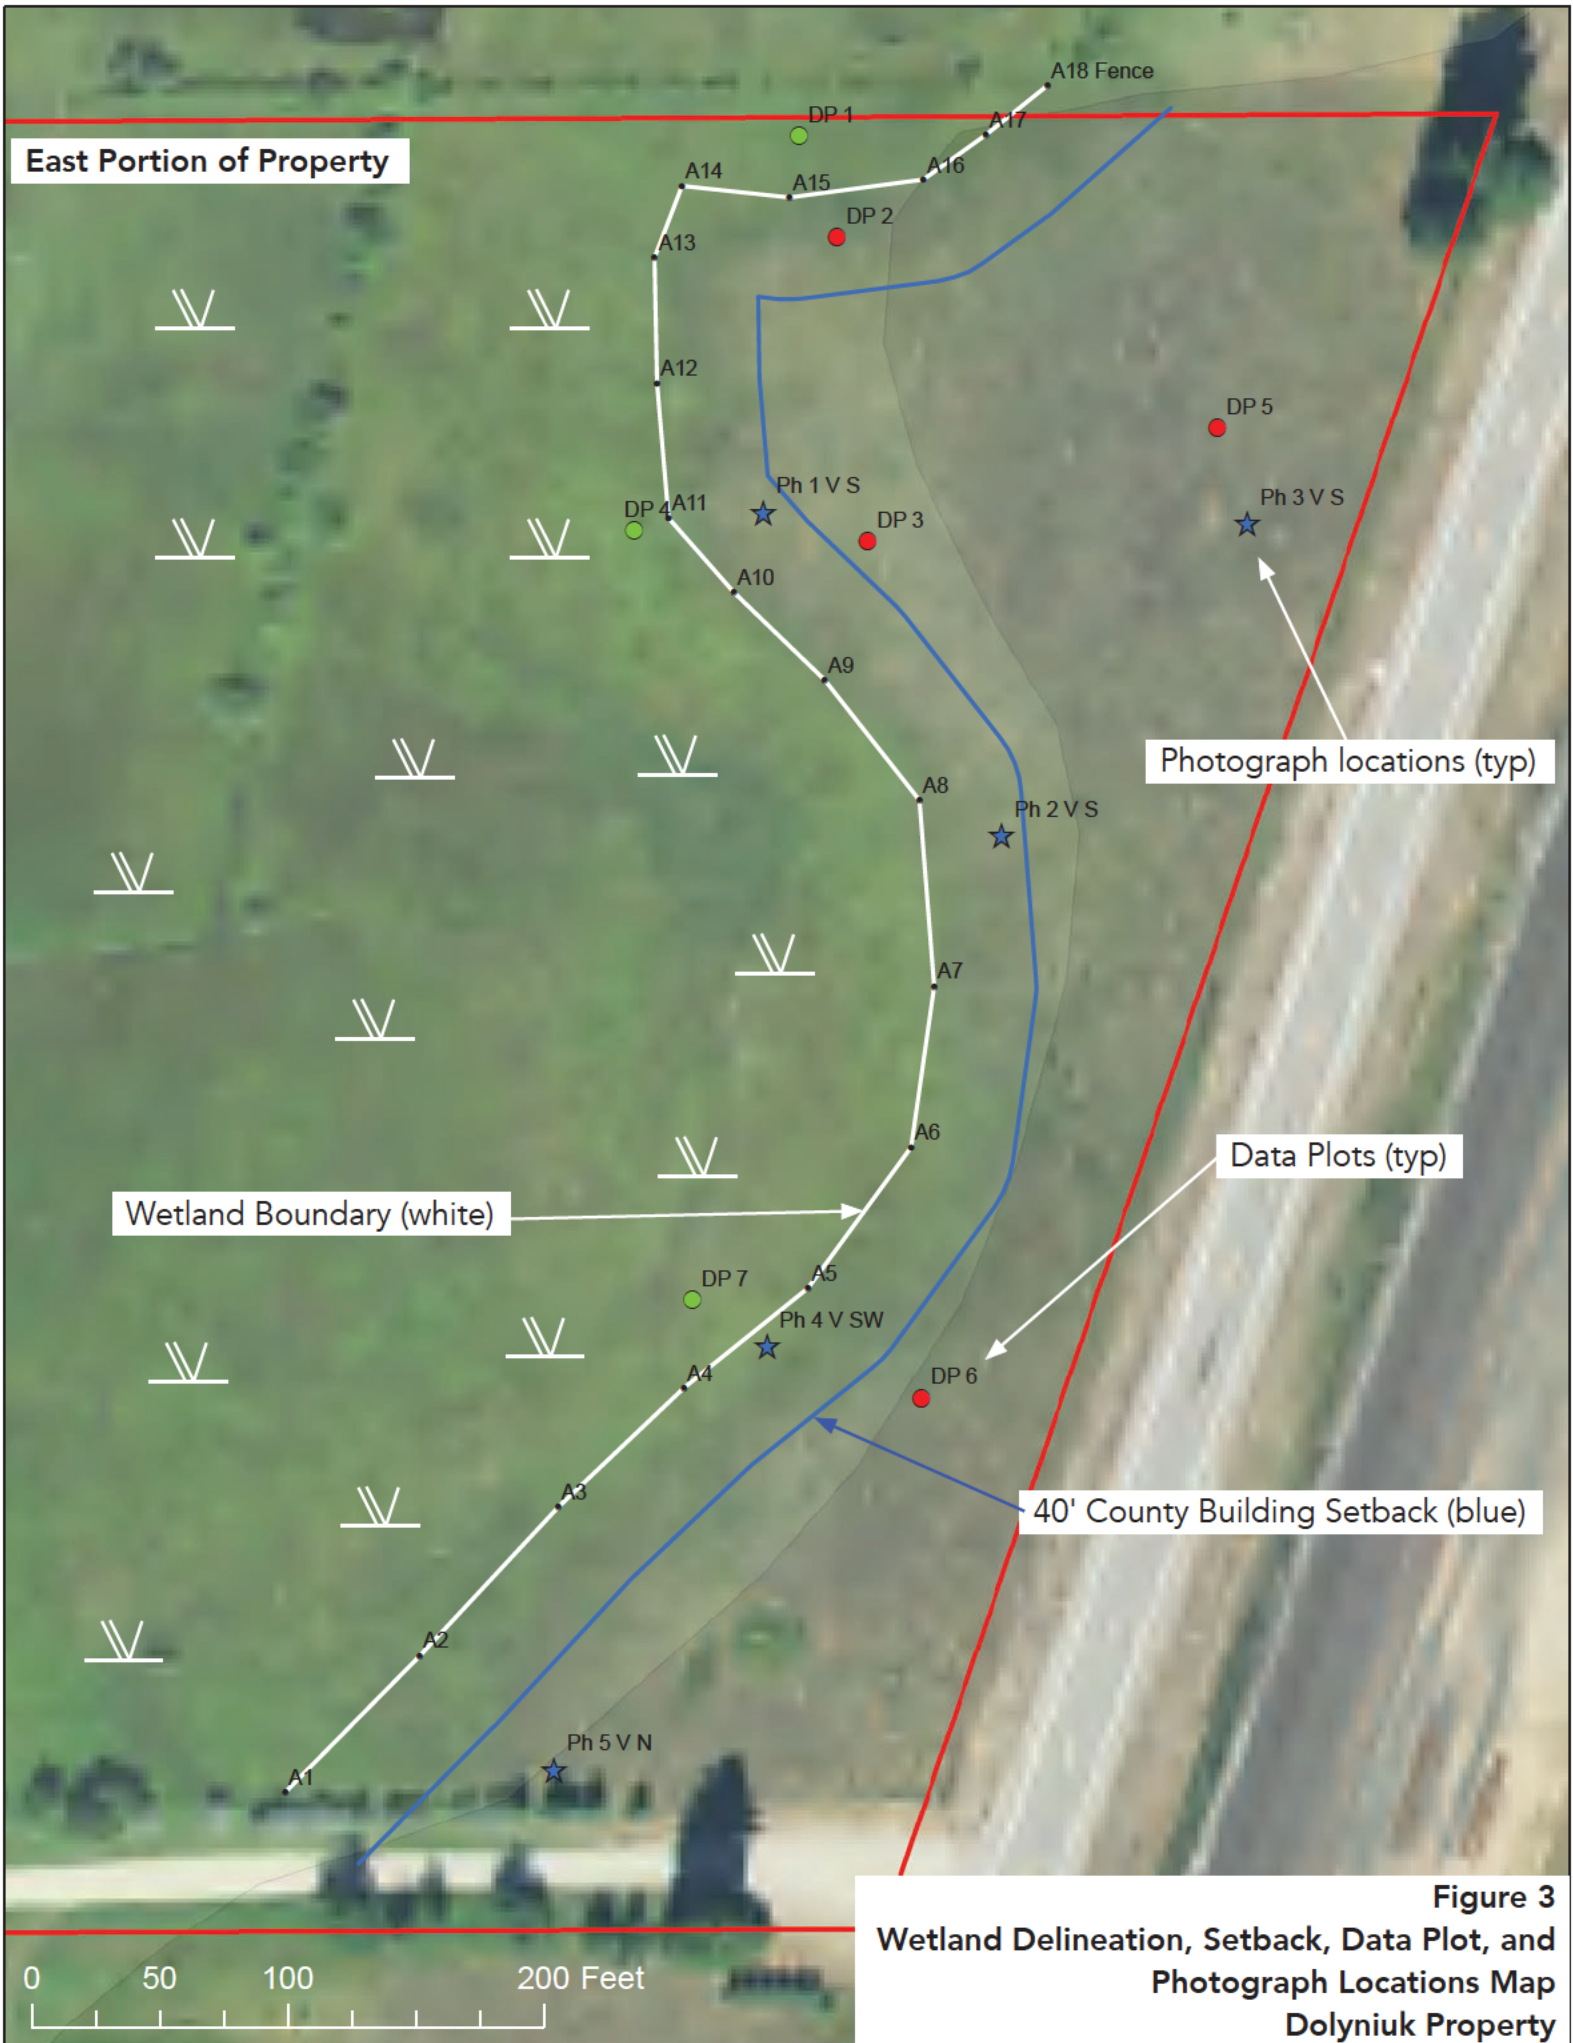
Figure 3 shows the properties with the GPSd wetland boundary points and the wetland boundaries (white lines). The wetland is located in the center of the property: the western edge was not delineated. It is located in a topographic low and contains some small willows, spiraea, sedge, goldenrod, and bentgrass. Due to the late season delineation, no hydrology was observed, but the area showed evidence of early season ponding. StreamStats of Idaho (<https://streamstats.usgs.gov/ss/>) showed a drainage starting at the western end of Cindy Lane, going through the center of the subject property (in the area of the NWI-mapped wetland) and discharging north, eventually into MacArthur Lake. I did not survey this possible drainage, but the area was dry during the August delineation.

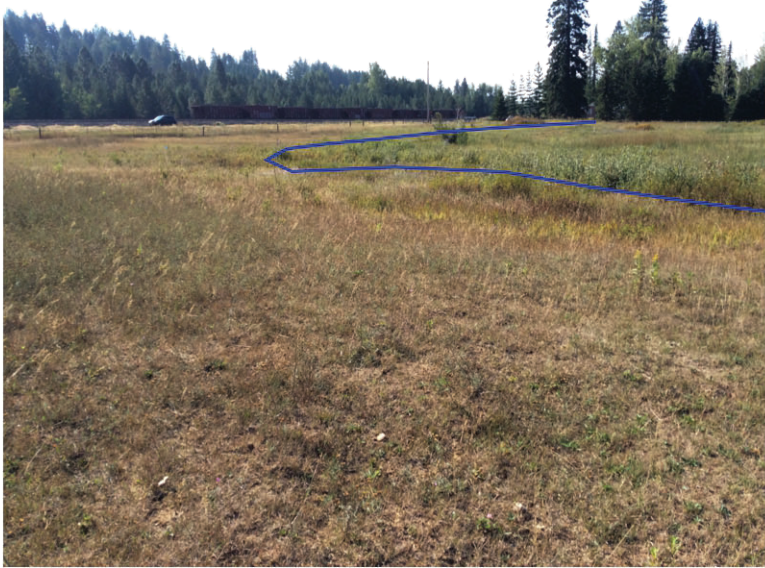
Photo 1. View south from upland mound area toward lower topography wetland (blue line). Upland consists of weedy vegetation (grazed) including knapweed, bentgrass, tumble mustard, plantain, and horseweed. Wetland contains minor amounts of low-growing willow, sedge, bentgrass, and goldenrod.

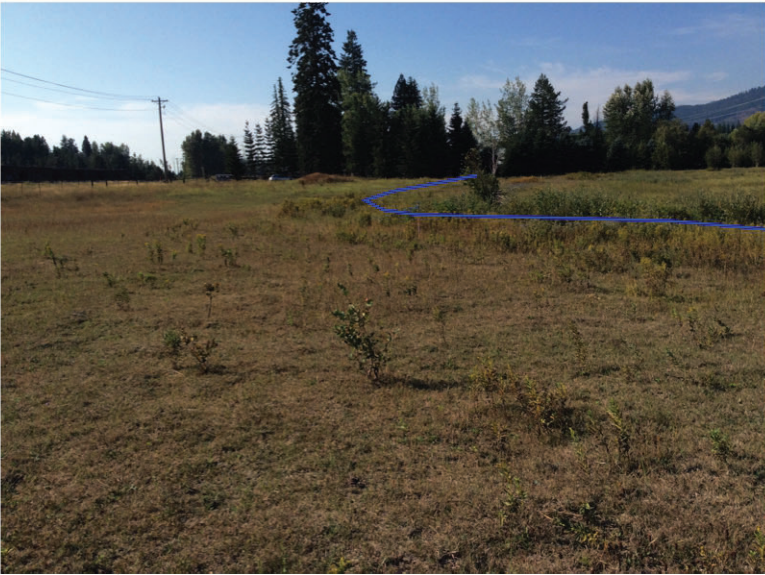
Photo 2. View south from upland mound area toward lower topography wetland (blue line). Upland consists of weedy vegetation (grazed) including knapweed, bentgrass, tumble mustard, plantain, and horseweed. Wetland contains minor amounts of low-growing willow, sedge, bentgrass, and goldenrod.

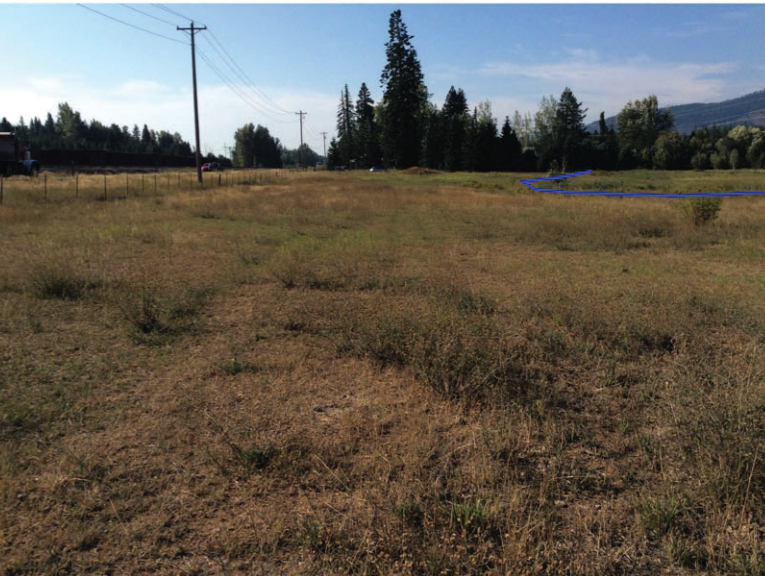
Photo 3. View south from upland mound area toward lower topography wetland (blue line). Upland consists of weedy vegetation (grazed) including knapweed, bentgrass, tumble mustard, plantain, and horseweed. Wetland contains minor amounts of low-growing willow, sedge, bentgrass, and goldenrod.

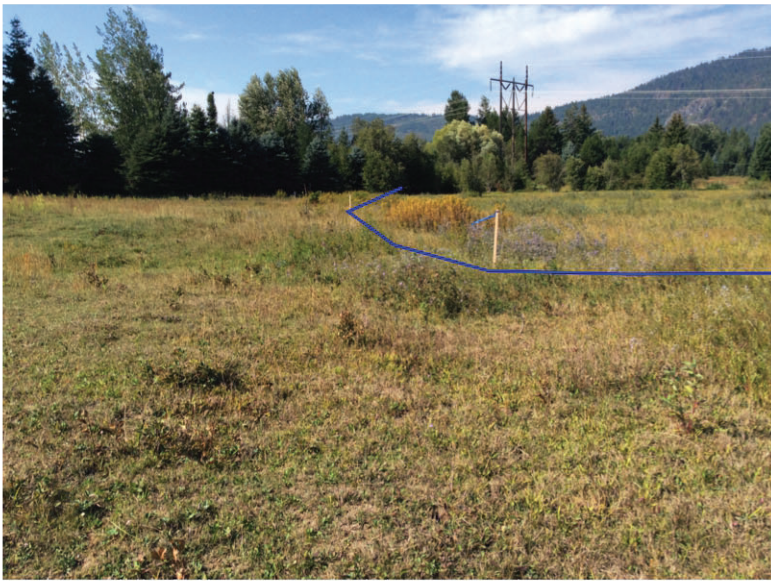
Photo 4. View southwest from upland mound area toward lower topography wetland (blue line). Upland consists of weedy vegetation (grazed) including knapweed, bentgrass, tumble mustard, plantain, and horseweed. Wetland contains minor amounts of low-growing willow, sedge, bentgrass, and goldenrod.

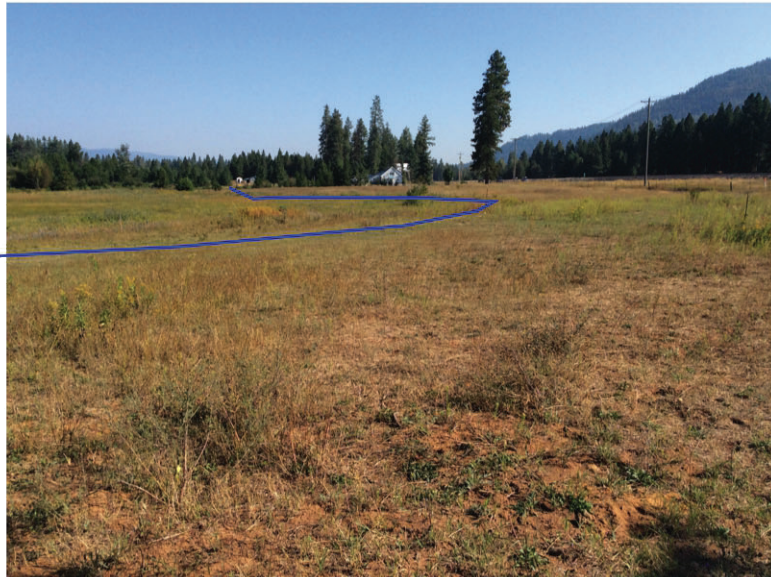
Photo 5. View north from southeast portion of property. Upland mound area in foreground, toward lower topography wetland (blue line). Upland consists of weedy vegetation (grazed) including knapweed, bentgrass, tumble mustard, plantain, and horseweed. Wetland contains minor amounts of low-growing willow, sedge, bentgrass, and goldenrod.
