**RE: Compliance Scope- Wetland Delineation for a New Site Build  
Harmoni Towers Proposed Monopole Location  
Verizon Wireless Name #: SPO Naples  
211 Cindy Lane, Sandpoint, Idaho  
RP59N01W097510A; T59N R 1W portion of Sec 9; (48.47723. -116.46786)  
GE<sup>2</sup>G Project # 311746**

**Compliance Scope**  
**Wetland Delineation for a New Site Build**  
**Harmoni Towers Proposed Monopole Location**  
**Verizon Wireless Name #: SPO Naples**  
**211 Cindy Lane, Sandpoint, Idaho**  
**GE<sup>2</sup>G Project # 311746**

**Appendix A:**  
**Wetland Delineation Letter Report**  
**for property located at 211 Cindy Lane, Sandpoint, ID**  
**Dolyniuk Trust Property**  
**dated September 11, 2023**

**Re: Wetland Delineation Letter Report for property located at 211 Cindy Lane, Sandpoint, ID  
Dolyniuk Trust Property: RP59N01W097510A; T59N R 1W portion of Sec 9; 48.47723. -116.46786**

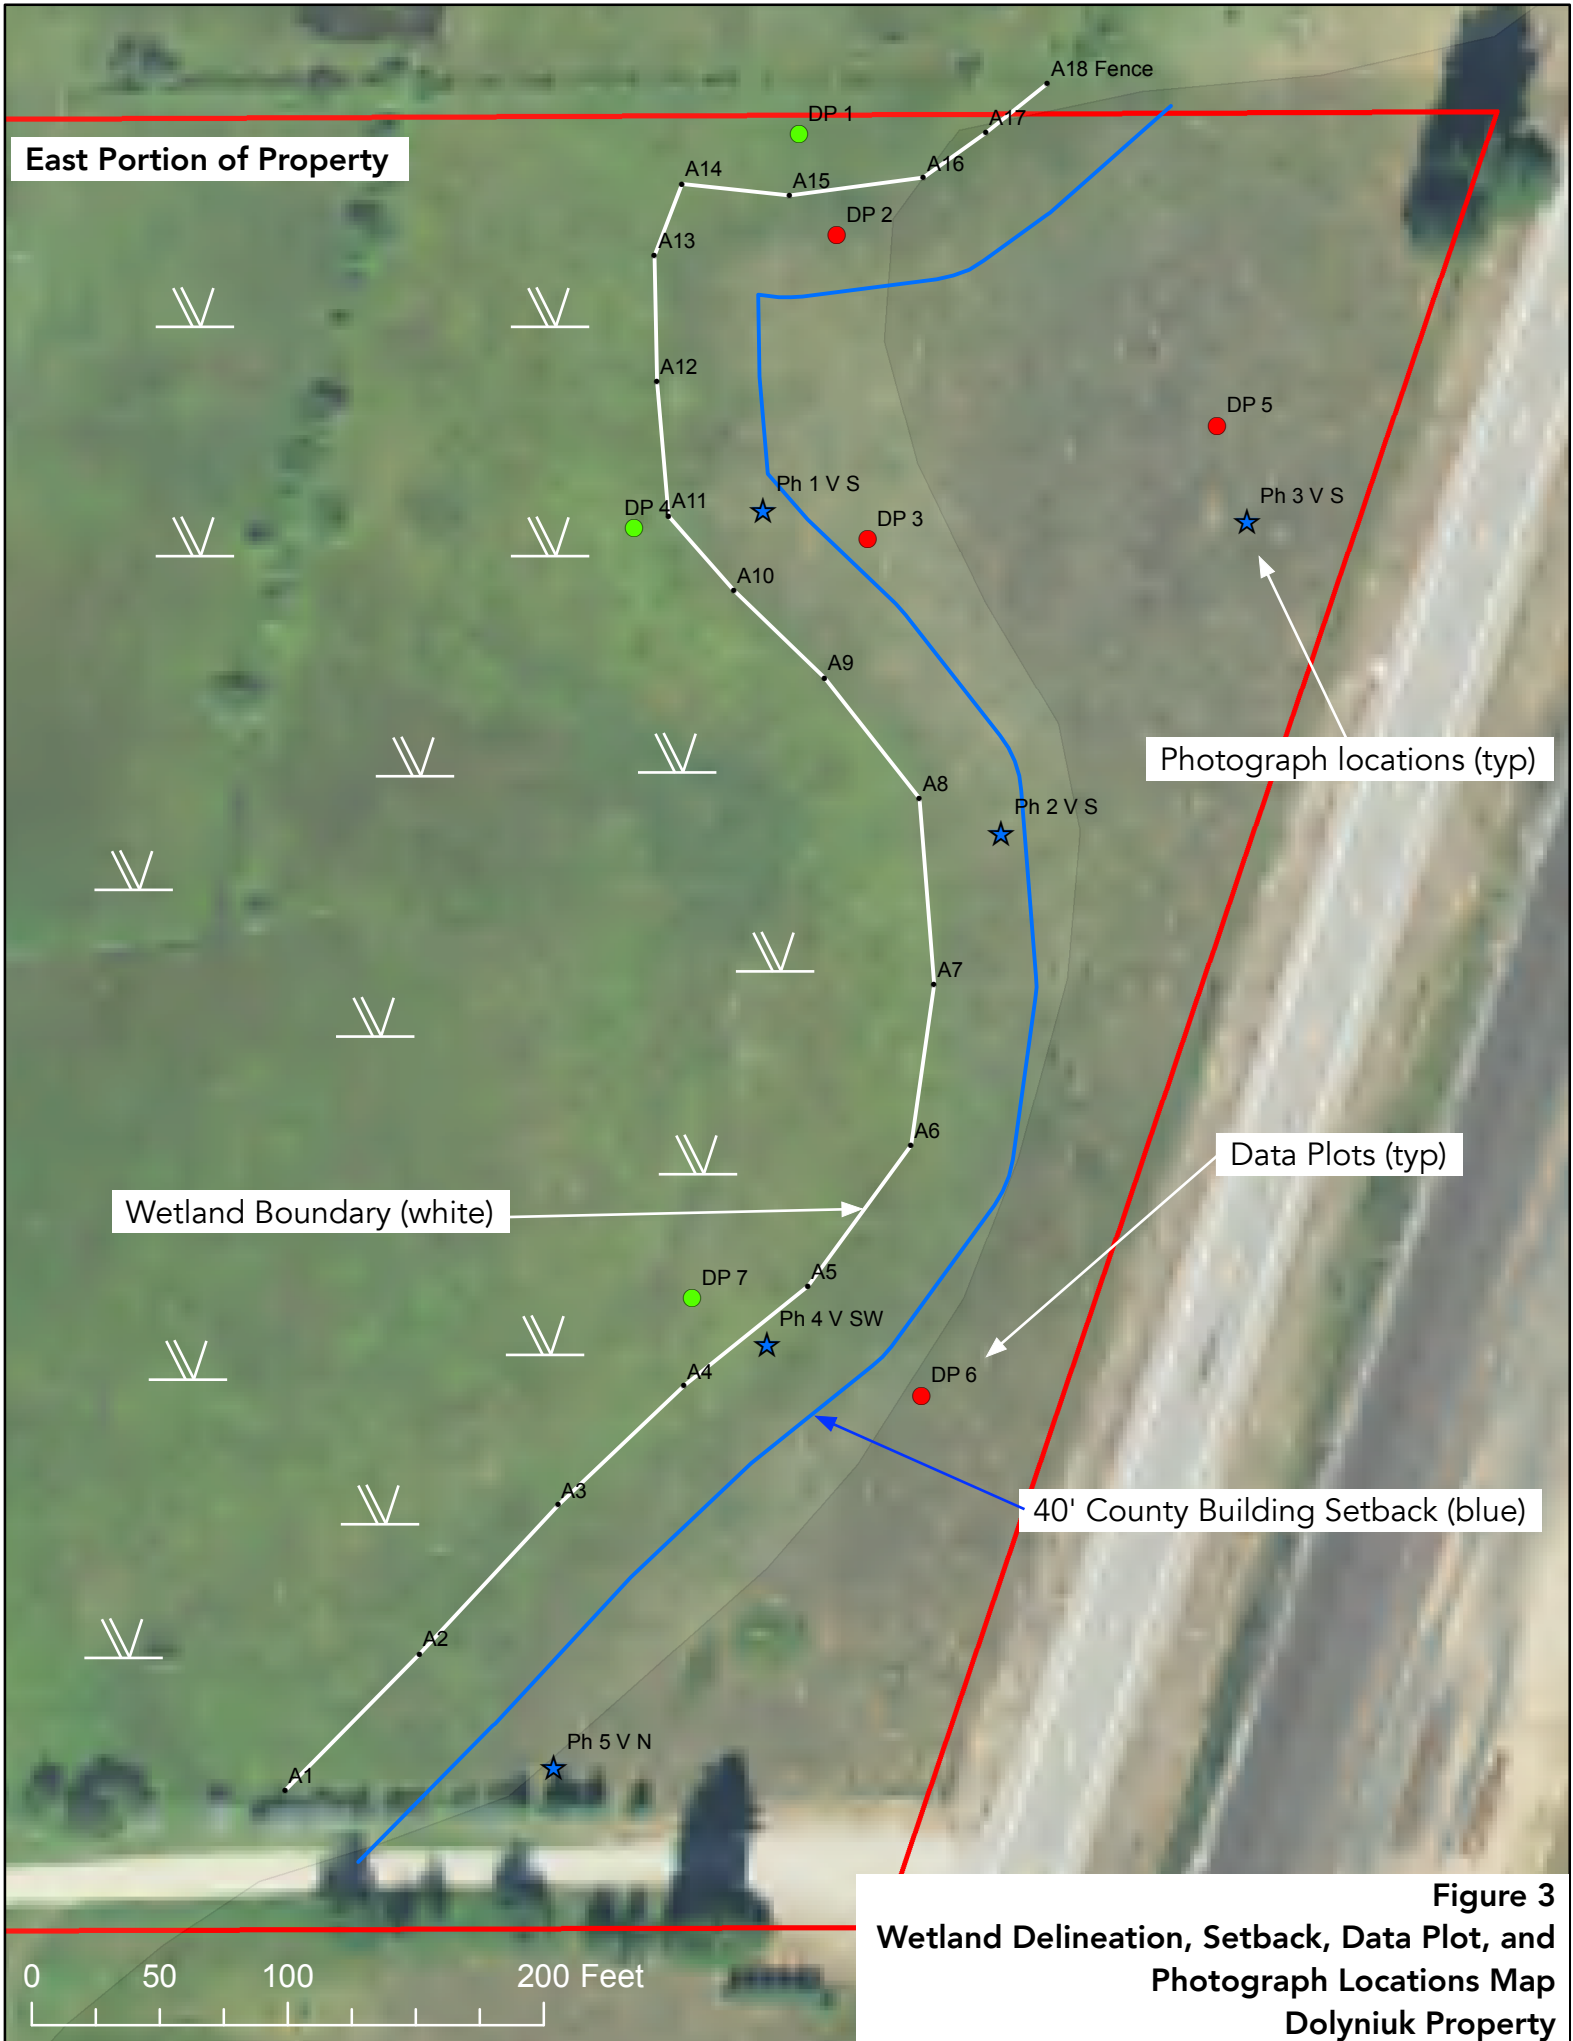
Figure 3 shows the properties with the GPSd wetland boundary points and the wetland boundaries (white lines). The wetland is located in the center of the property: the western edge was not delineated. It is located in a topographic low and contains some small willows, spiraea, sedge, goldenrod, and bentgrass. Due to the late season delineation, no hydrology was observed, but the area showed evidence of early season ponding. StreamStats of Idaho (<https://streamstats.usgs.gov/ss/>) showed a drainage starting at the western end of Cindy Lane, going through the center of the subject property (in the area of the NWI-mapped wetland) and discharging north, eventually into MacArthur Lake. I did not survey this possible drainage, but the area was dry during the August delineation.

Bonner County imposes a 40' building-to-wetland boundary setback (shown on Figure 3 as a blue line).

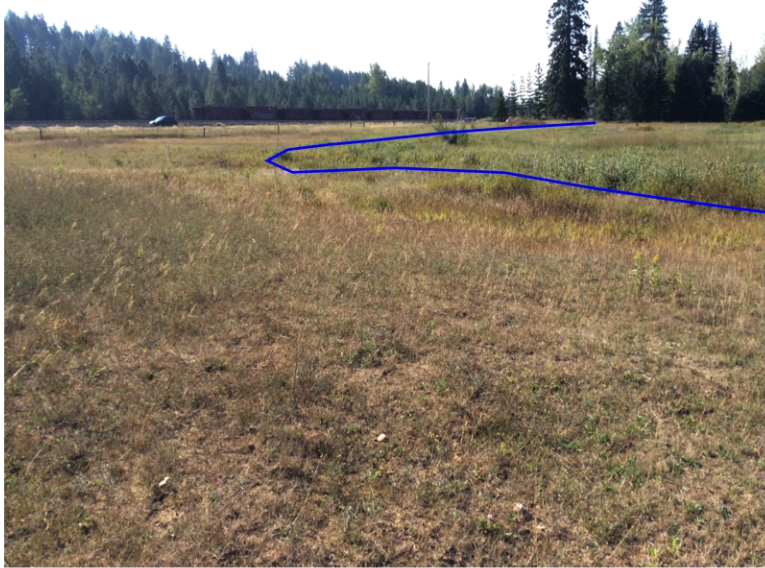
Photo 1. View south from upland mound area toward lower topography wetland (blue line). Upland consists of weedy vegetation (grazed) including knapweed, bentgrass, tumble mustard, plantain, and horseweed. Wetland contains minor amounts of low-growing willow, sedge, bentgrass, and goldenrod.

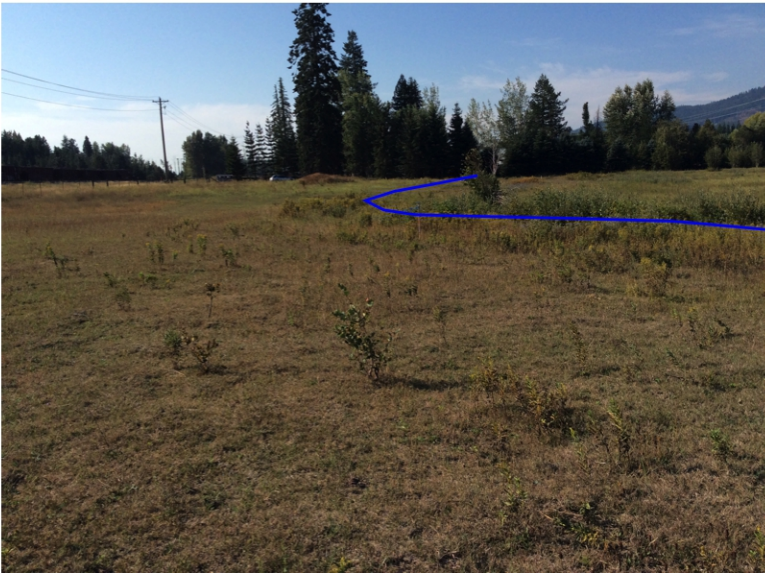
Photo 2. View south from upland mound area toward lower topography wetland (blue line). Upland consists of weedy vegetation (grazed) including knapweed, bentgrass, tumble mustard, plantain, and horseweed. Wetland contains minor amounts of low-growing willow, sedge, bentgrass, and goldenrod.

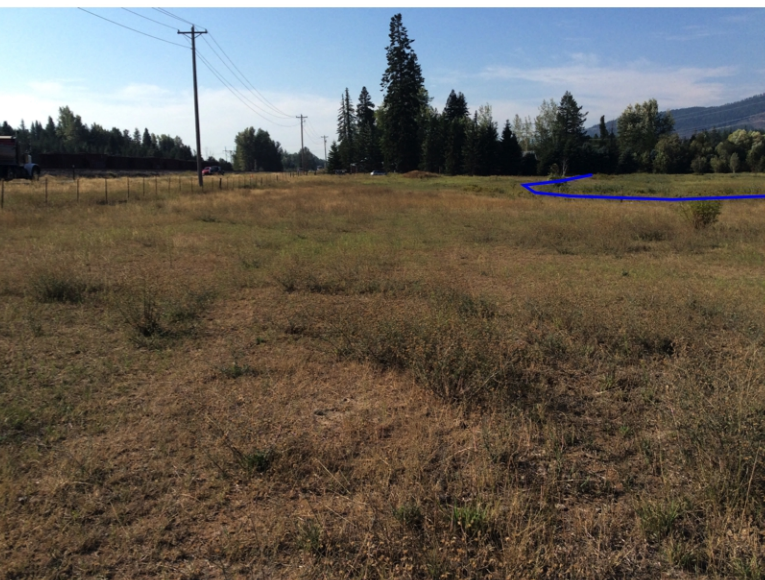
Photo 3. View south from upland mound area toward lower topography wetland (blue line). Upland consists of weedy vegetation (grazed) including knapweed, bentgrass, tumble mustard, plantain, and horseweed. Wetland contains minor amounts of low-growing willow, sedge, bentgrass, and goldenrod.

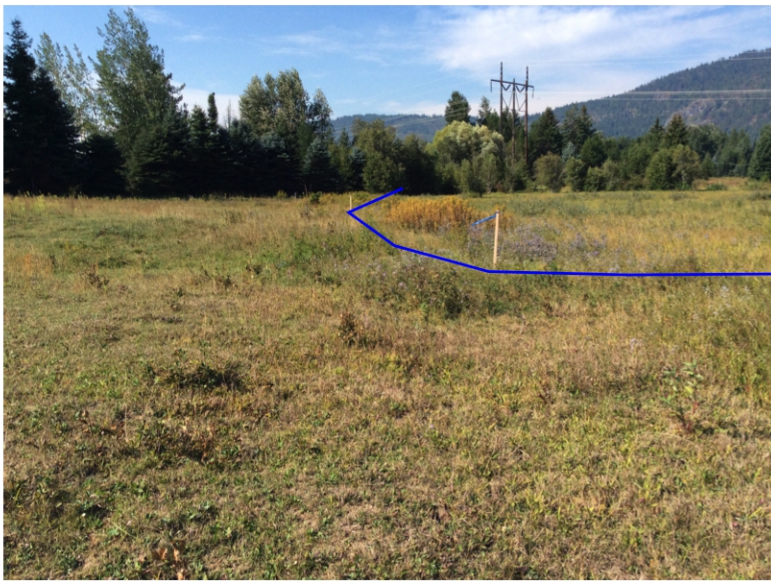
Photo 4. View southwest from upland mound area toward lower topography wetland (blue line). Upland consists of weedy vegetation (grazed) including knapweed, bentgrass, tumble mustard, plantain, and horseweed. Wetland contains minor amounts of low-growing willow, sedge, bentgrass, and goldenrod.

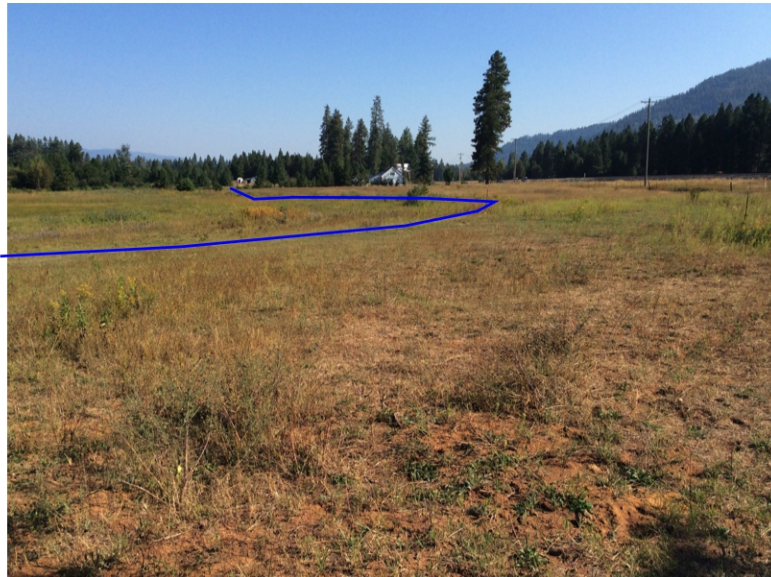
Photo 5. View north from southeast portion of property. Upland mound area in foreground, toward lower topography wetland (blue line). Upland consists of weedy vegetation (grazed) including knapweed, bentgrass, tumble mustard, plantain, and horseweed. Wetland contains minor amounts of low-growing willow, sedge, bentgrass, and goldenrod.
