Re: Wetland Assessment Report for property south of Sagle Rd, ID RP56N02W027950A; T 56N, R 2W portion of Section 2

Per your request for environmental services, I am submitting this Wetland Assessment Report for the property referenced above (Figure 1). On June 6, 2024, I visited the site to determine if there are wetlands on the property as the National Wetland Inventory (NWI) mapped an emergent (non-woody, temporarily flooded) wetland on the property. I completed four Data Plots and photo-documented current site conditions. The USGS 7.5' topographic quad is Sagle, ID.

Photosheet Brown Property June 6, 2024

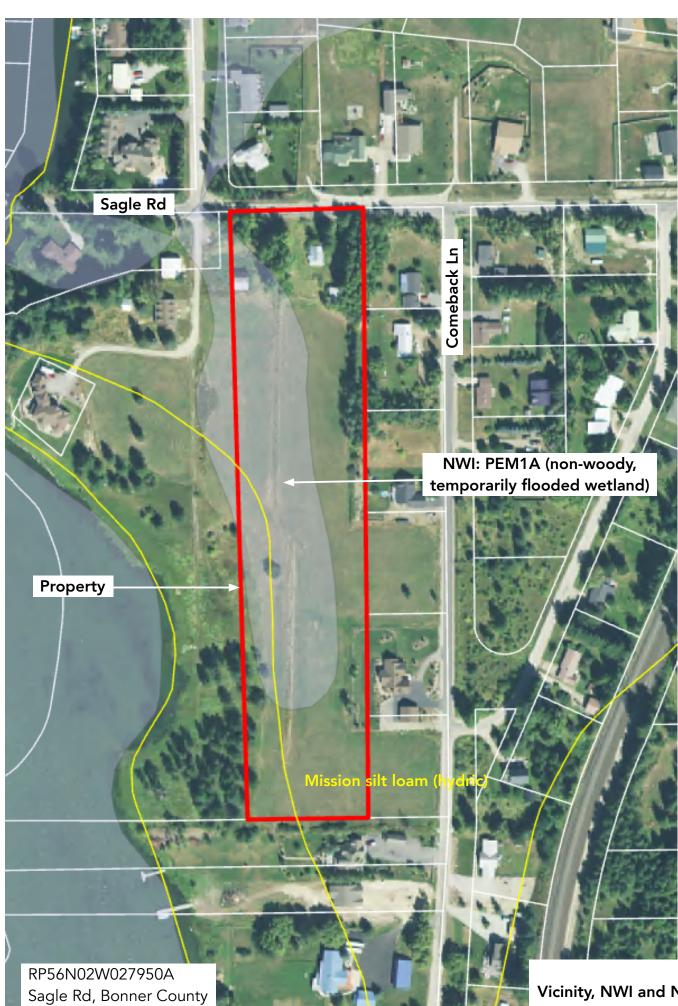
Figure 1 Vicinity, NWI and NRCS Map Brown Property

The Natural Resources Conservation Service (NRCS) mapped the property as being underlain by Mission silt loam (hydric) (Figure 1). The soil profiles investigated within the NWI-mapped wetland area did not show hydric indicators.

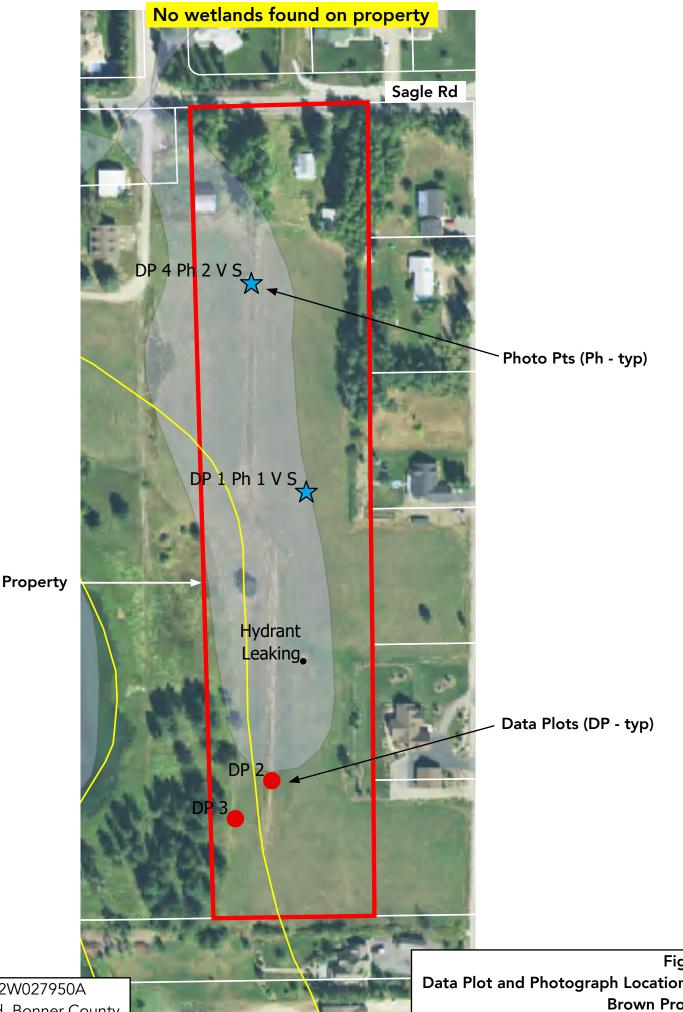
Figure 2 Data Plot and Photograph Location Map **Brown Property**

The NWI mapped a band of PEM1A (emergent, temporarily flooded) wetland through the center and western portion of the property (Figure 2). Hydrology was not observed on the property, except for some surface leakage from a hydrant (Figure 2). No hydrologic indicators were observed or likely in the remaining areas.

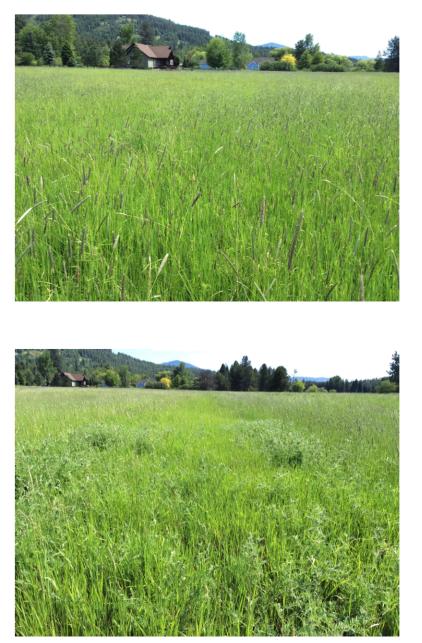
Photo 1: View south from Data Plot 1. Vegetation is not hydrophytic, soil is not hydric, no evidence of wetland hydrology.

Photo 2: View south from Data Plot 4. Vegetation is not hydrophytic, soil is not hydric, no evidence of wetland hydrology.
